CASE STUDY

HEATHROW

PROJECT
Heathrow replaces roofs damaged
by the vortex effect

FIGHTING THE VORTEX

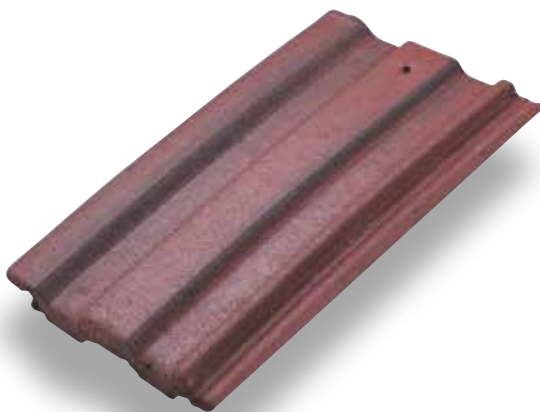
The Redland 49 tile, with its ability to be fixed both top and bottom, is the first choice product used to replace roofs around Heathrow Airport that have been damaged by the vortex effect.

A vortex is a circulating eddy of air, like a mini-tornado, caused by low-flying aircraft. The effect, which is particularly significant as aircraft come in to land, is to suck tiles off the roof. Replacement tiles need to be firmly fixed and Redland 49 tiles allow for both clips and nails to be used as required by the BRE guidance document DG467. The small format of the tile combined with this dual fixing provides the most secure fixing possible.

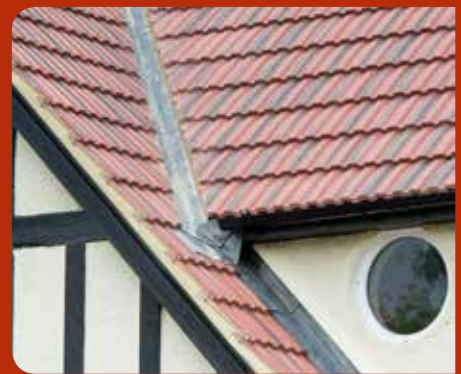
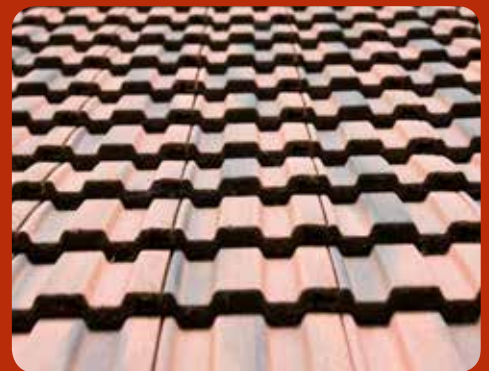
A compact and visually appealing interlocking cambered tile that has defined the roofscapes of London and the south-east for more than 65 years. The Redland 49 tile is easy to handle and install so offers both speed and economy as a roofing material.

Redland 49 is a small interlocking concrete tile that has been in manufacture for 65 years and is particularly popular in London and the South East where it is the ubiquitous tile of choice for huge areas of post-war housing.
